Site Context 6740 LONE TREE WAY

CANNON DESIGN GROUP March 8, 2023

Concerns and Issues 6740 LONE TREE WAY

Recommendations 6740 LONE TREE WAY

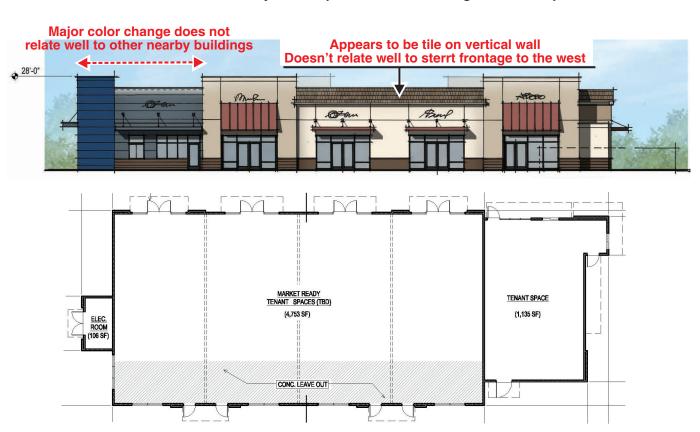
EAST ELEVATION

Way too many colors

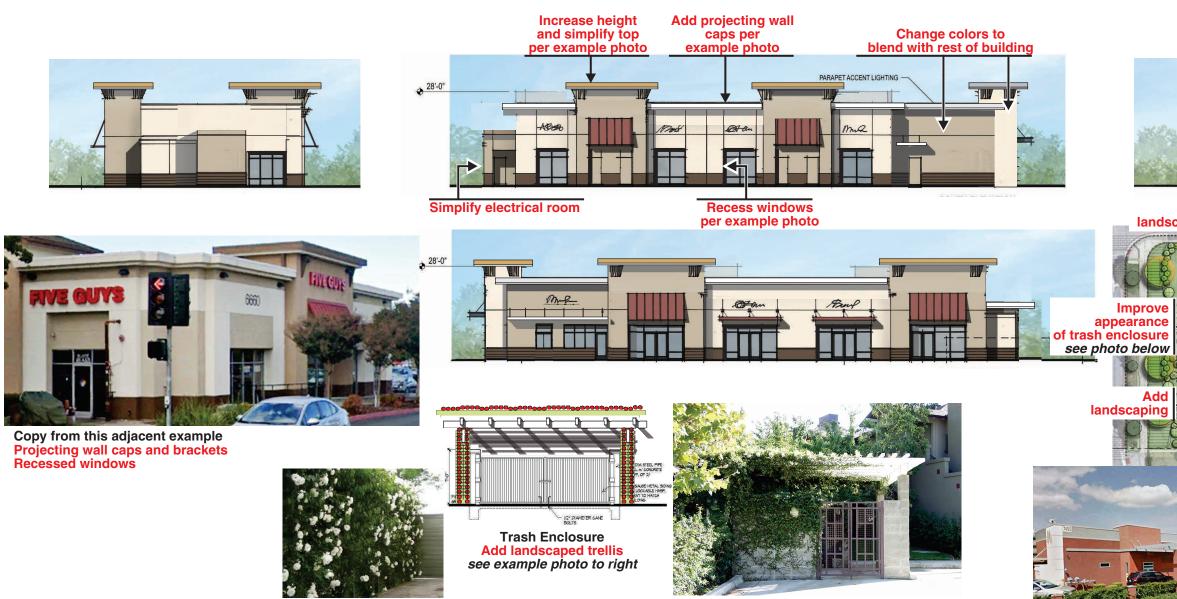
RECOMMENDED ELEVATIONS

Add better landscaping and consider trellis see example photo to left
